# Effects of uncharacteristically large and intense wildfires on native fish: 14 years of observations on the Boise National Forest

By: Tim Burton, Forest Fisheries Biologist

October, 2000

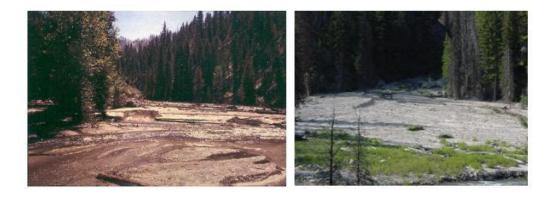
Figure 4. Mouth of Trapper Creek in 1996 (left), and in 2000 (right).

Habitat conditions and trout densities declined dramatically immediately following the debris floods in 1995/96. However, just 4 years later in 2000, habitat conditions and redband trout populations rebounded significantly. Large numbers of young-of-the-year and juvenile fish observed in the year 2000 samples indicated strong productivity following the changes resulting from wildfire. Redband trout are particularly productive in habitats with high pool frequency and low substrate fine sediments. The post-fire floods rejuvenated habitats by bringing in large amounts of large rock, woody debris, and nutrients that resulted in higher fish densities than before the fire. These observations suggest that debris floods following wildfires in the Boise Basin may be positive for redband trout.

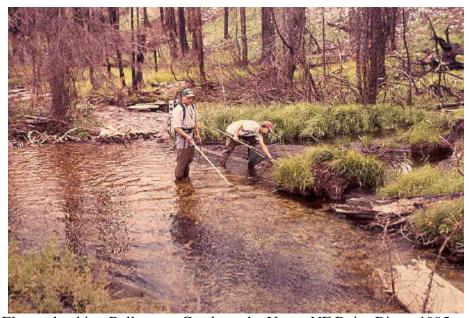
Figure 6. . Electroshocking Ballentyne Creek on the Upper NF Boise River, 1995.

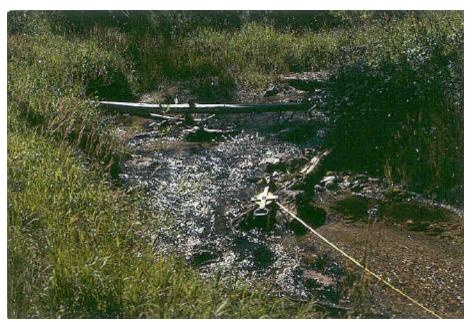
Figure 12. Monitoring station on Boundary Creek, showing heavily sediment substrate in 1988, one year after the fire.

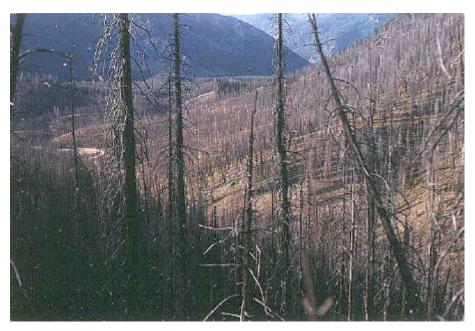
Figure~13.~.~Boundary~Creek~watershed, showing~the~extent~and~intensity~of~burning~after~the~Deadwood~Summit~Fire~of~1987.

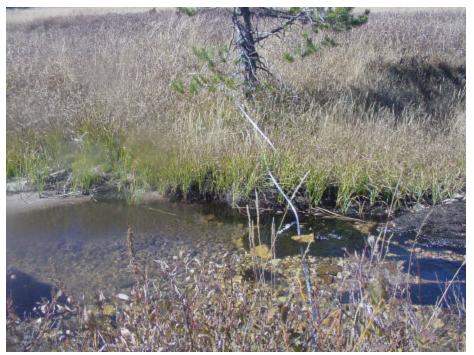
Figure 14. The Dagger Creek monitoring station showing clean substrate after mostly light intensity burning.

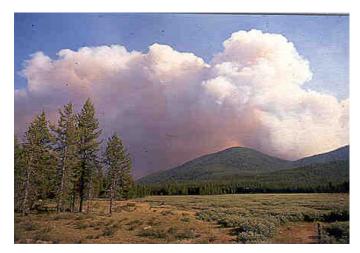
Figure 15.: The County Line Fire burns in Fir Creek Watershed, August, 1992. RIGHT: Aftermath of the fire resulted in subalpine fir and lodgepole pine stand replacement.

Approximately 2500 acres of the 8000 acre County Line Fire burned within the Fir Creek Watershed. Within this watershed, the fire burned mostly at high intensity (Figure 15). The subalpine fir and lodgepole pine stands in this watershed are associated with a unique combination of topography, climate, and vegetation that is typified by large-scale, stand replacement fires.

High intensity stand replacement fires in the Fir Creek area were observed to denude the forest floor of effective ground cover, exposing bare soil to erosive forces for some period of time. Once a vegetative layer is re-established, surface erosion presumably would decline dramatically. Recovery of the ground cover has been slow. The most significant erosional event occurred 5 years after the fire, in 1997.

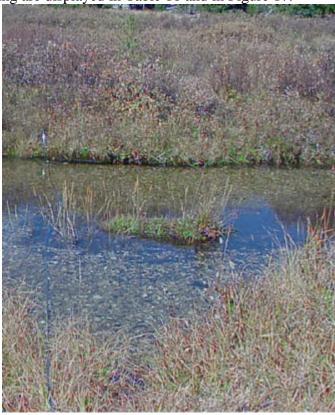
Figure 17. Fir Creek monitoring station, showing stream substrate in the year 2000. The island forming in the center of the channel is new since 1997.

Results of the monitoring are displayed in Table 10 and in Figure 17.

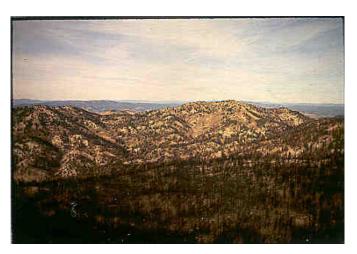
Figure 21. Upper Rattlesnake Creek: LEFT – discontinuous patches of burned ponderosa pine and Douglas fir forests. RIGHT – burned forests and campground tables at Tipton Flat in Upper Rattlesnake Creek.

Similar observations were made in Upper Rattlesnake Creek (Corley, personal communication). It was not known to what extent the fire had reduced bull trout and redband trout numbers, because pre-fire data were unavailable, however electrofishing transects were established in both of these watersheds, and trout abundance was observed at these transects after the 1992 event. Upper Rattlesnake Creek experienced debris flooding in the winter and spring of 1997 (Figure 21), and habitats now reflect the effects of that event.

Habitat variables were measured at the 5 fish monitoring stations in Upper Rattlesnake Creek (above Tipton Flat campground – see photos in Figures 19 and 20) in 1994 and again in 2000. Debris flows occurred in this reach of stream in 1997 (see Figure 21). Table 12 displays results of these measurements. Fine sediment increases from 7 to 14 percent likely reflect increased substrate sedimentation resulting from the 1997 debris flows. Decreased width-to-maximum depth ratio probably reflects the additional channel scour resulting from higher post-fire flood regimes. Large woody debris abundance increased at these stations, reflecting the large number of dead trees that have fallen into the stream. Pool frequency declined slightly after the floods, but remains high as a result of the additional large wood debris. Much of the debris that has fallen is still suspended over the channel and, as yet, has not created pools (see figure 23).

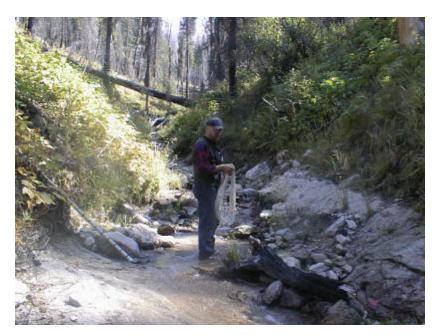
Figure 27. 1998 Sister Creek Reach 1 showing post-debris torrent channel scour.

Sister Creek experienced a localized debris torrent in 1996 that originated in the stream channel headwaters that caused localized loss of LWD and reduced streambank stability. This watershed was mostly burned at high intensity (see Figure 1). It is unlikely that salvage logging had any substantial influence in triggering the debris torrent in Sister Creek.

With the exception of Sister Creek, streams in the Thunderbolt Fire area have not been altered by post-fire events. The debris flow in Sister Creek resulted in declines of large woody debris and bank stability. Sister Creek was the only stream burned mostly at high intensity. Large proportions of the other watersheds burned at low intensity or did not burn. These observations suggests that where large areas burn at high intensity, post-fire debris floods are likely to occur.
